The Vajont Dam Disaster

*TeLL-Net Kick-off Assembly
Kobe Japan 19-20 January 2006*

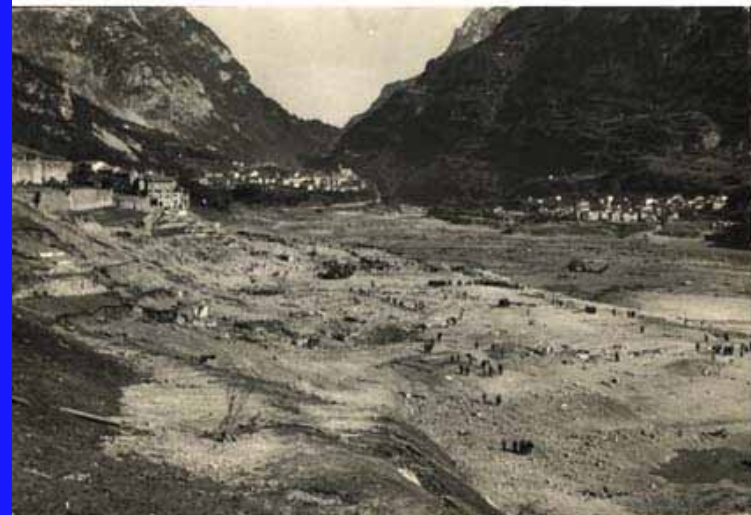
The Vajont reservoir is located along the lower reaches of the River Vajont, close to its confluence with the R. Piave, some 100 km NNW of Venice

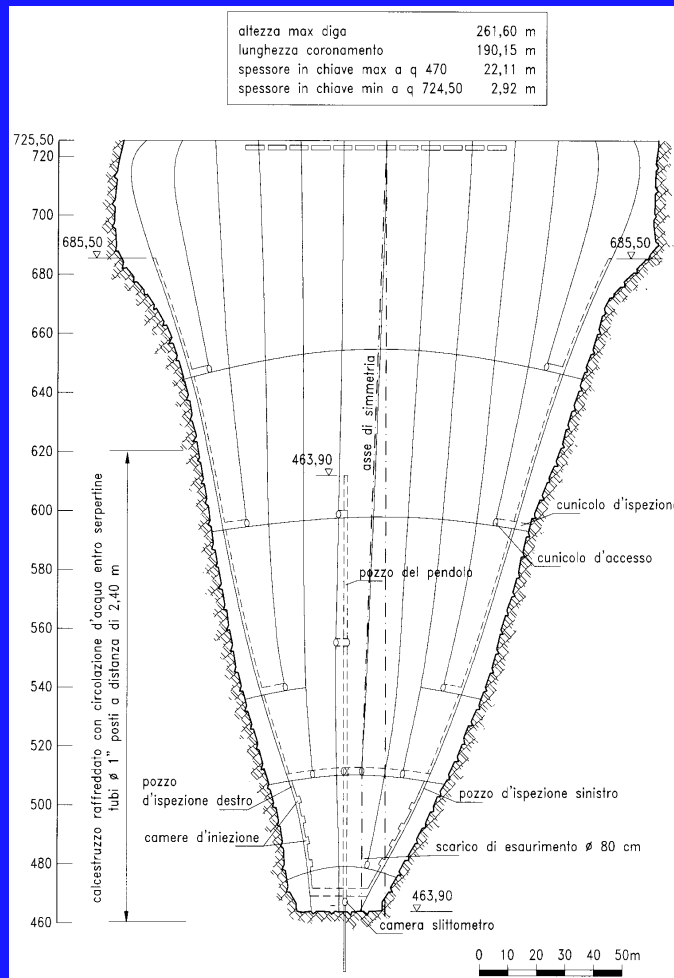
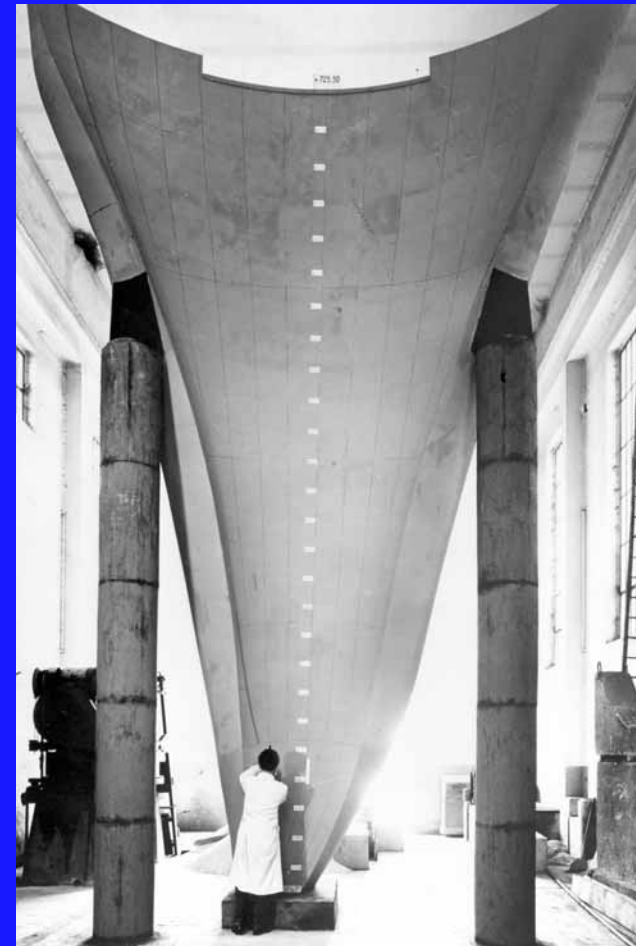
The dam is 261.60 m high and 190 m across the top, and at the time of construction was the highest and one of the most advanced double-arched dams in the world.

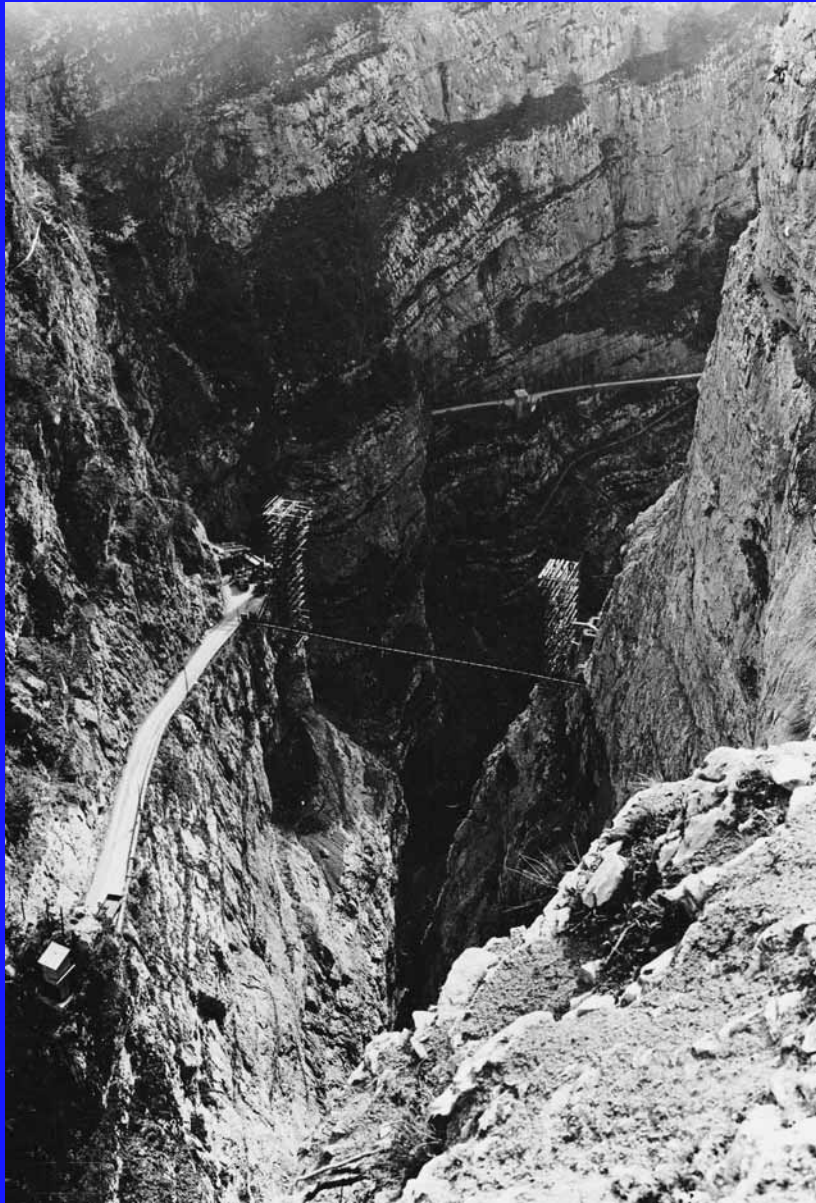
TECHNICAL DATA OF THE DAM

<i>Beginning of construction</i>	<i>January 1957</i>
<i>End of construction</i>	<i>September 1959</i>
<i>Excavated rock</i>	<i>400.000 m³</i>
<i>Used concrete</i>	<i>360.000 m³</i>
<i>Height of the dam</i>	<i>261.60 m</i>
<i>Thickness at the base</i>	<i>22.11 m</i>
<i>Thickness at the top</i>	<i>3.40 m</i>
<i>Total water storaged</i>	<i>168 million m³</i>
<i>Useful water capacity</i>	<i>150 million m³</i>

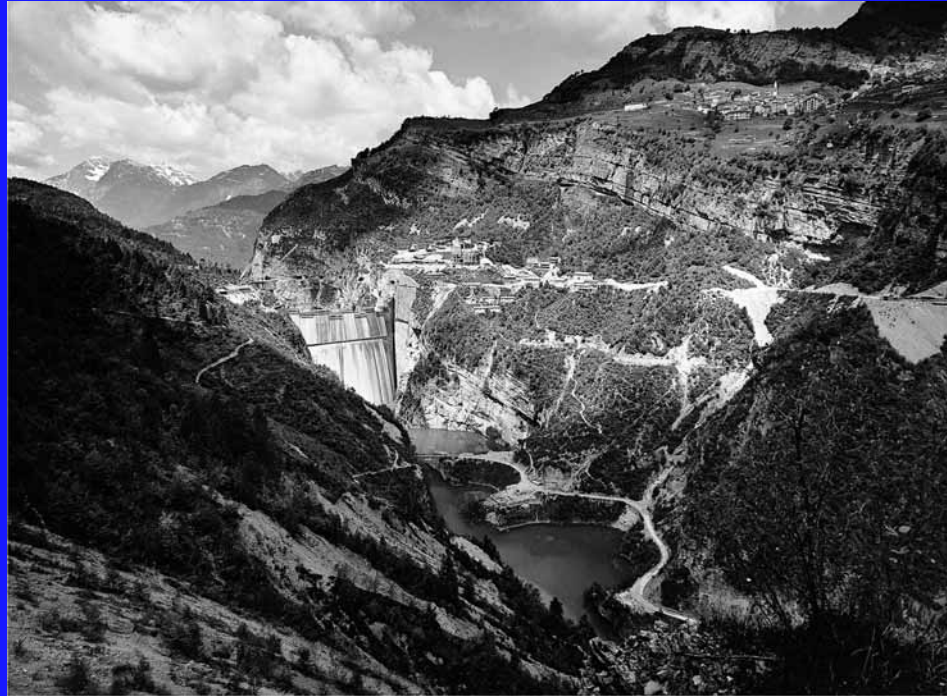
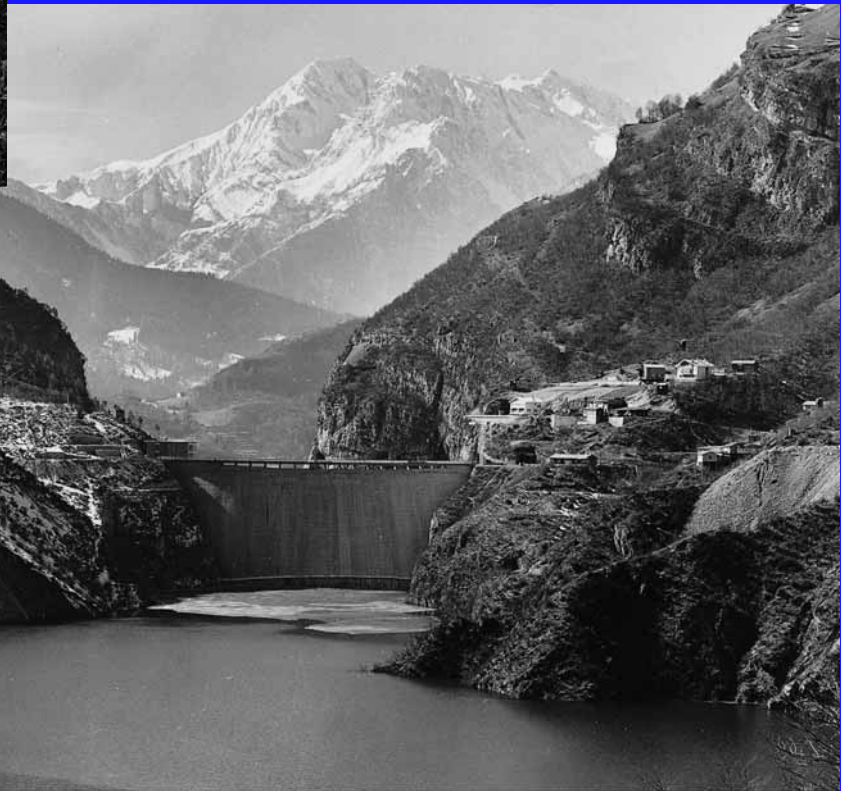
Mt. Toc and the southern slope of the Vajont valley **were more prone to instability than expected**, since the mountain's outer flanks consisted of **an ancient landslide** deposit and not of bedrock, as initially inferred.

After the reservoir level had been raised and lowered several times, **the southern margin of Mt. Toc** became eventually destabilised and, after nearly three years of intermittent creeping, it **catastrophically collapsed at 22:39 hours on 9th October 1963.**

Within **30-40 seconds**, some **270 million m³ of rock** crashed into the reservoir, expelling a wave of water about **100-150 m high** over the dam

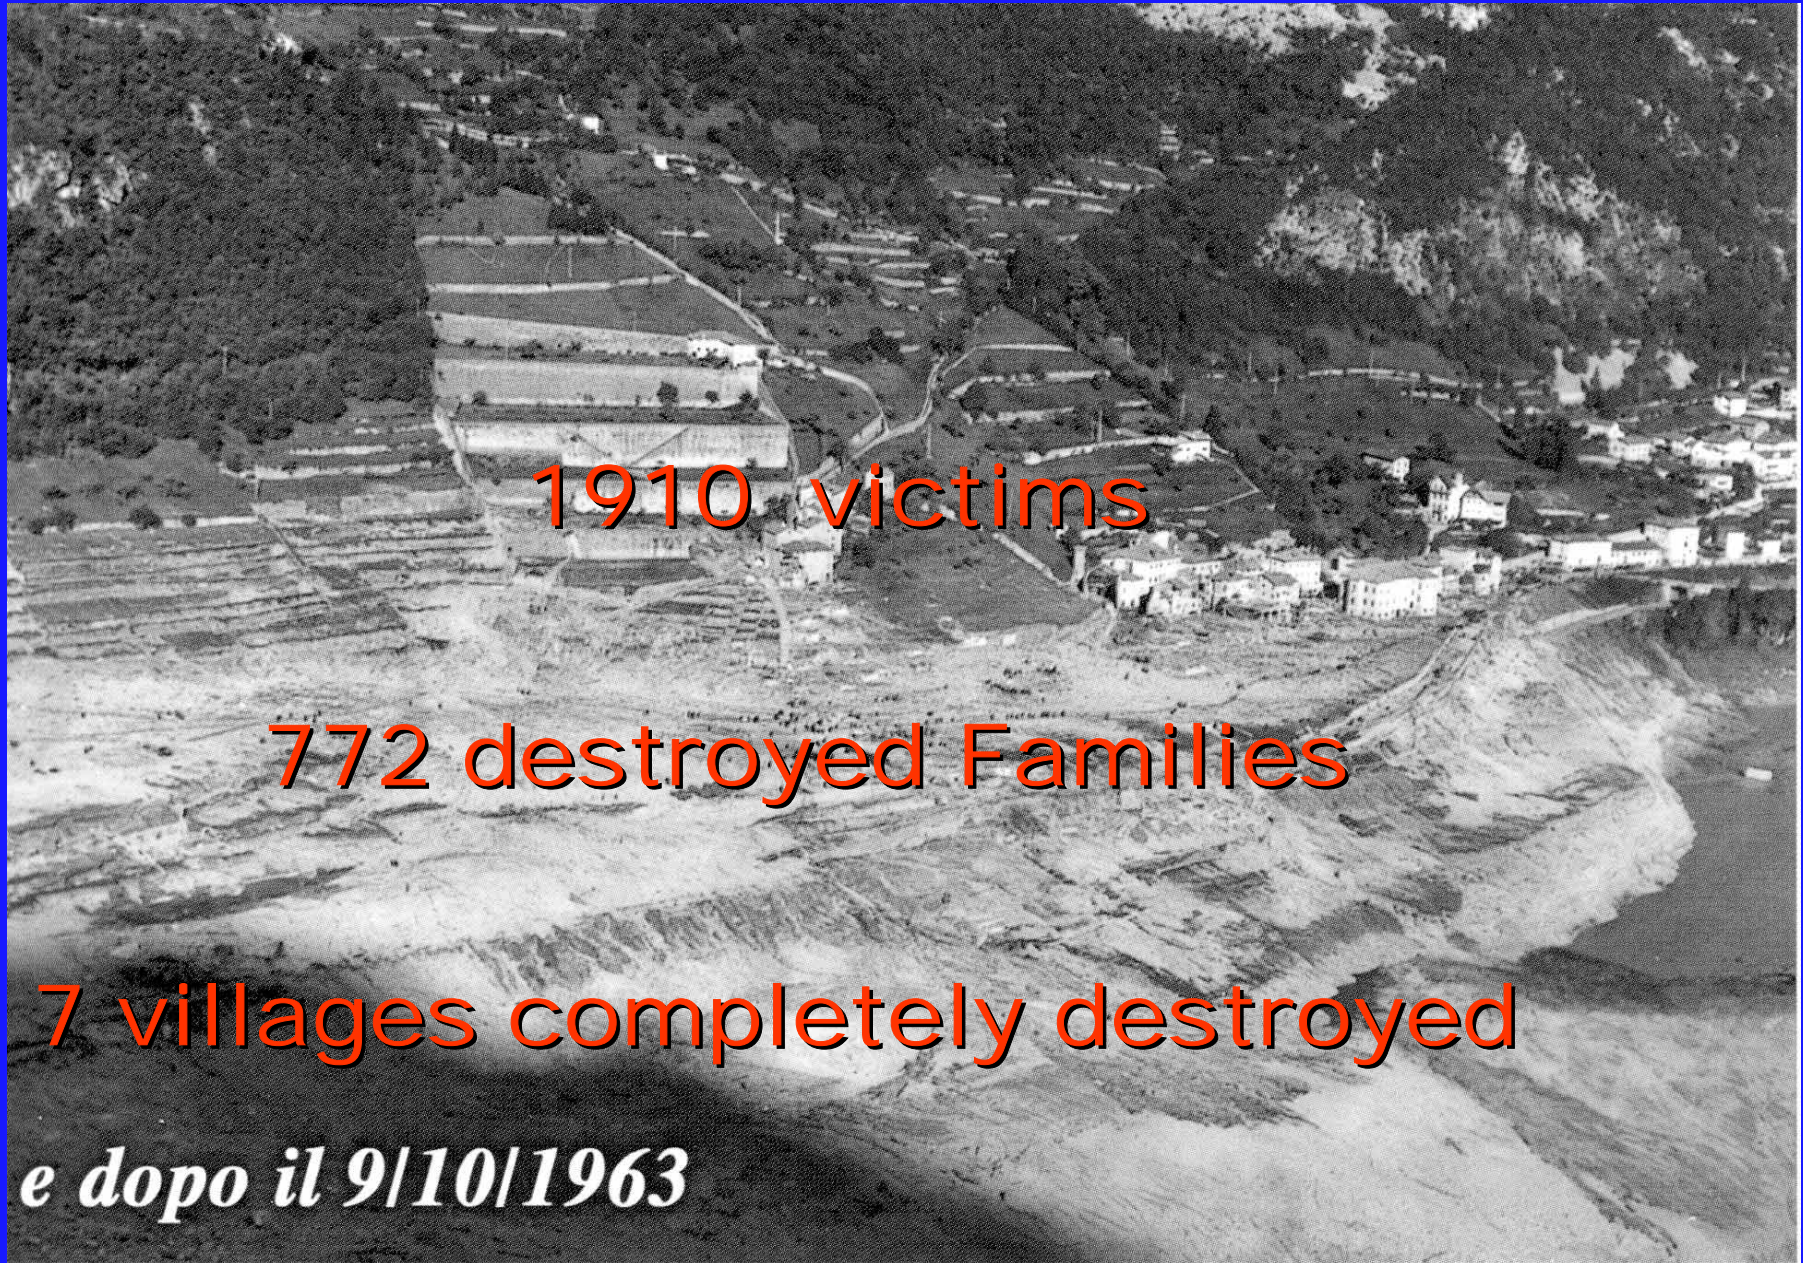
e dopo il 9/10/1963

1910 victims

772 destroyed Families

7 villages completely destroyed
